White Sands Test Facility

**ENVIRONMENTAL ASSESSMENT FOR THE
MID-PLUME CONSTRICTION AREA
REMEDIATION PROJECT**

MID-PLUME CONSTRICTION AREA (MPCA) REMEDIATION PROJECT

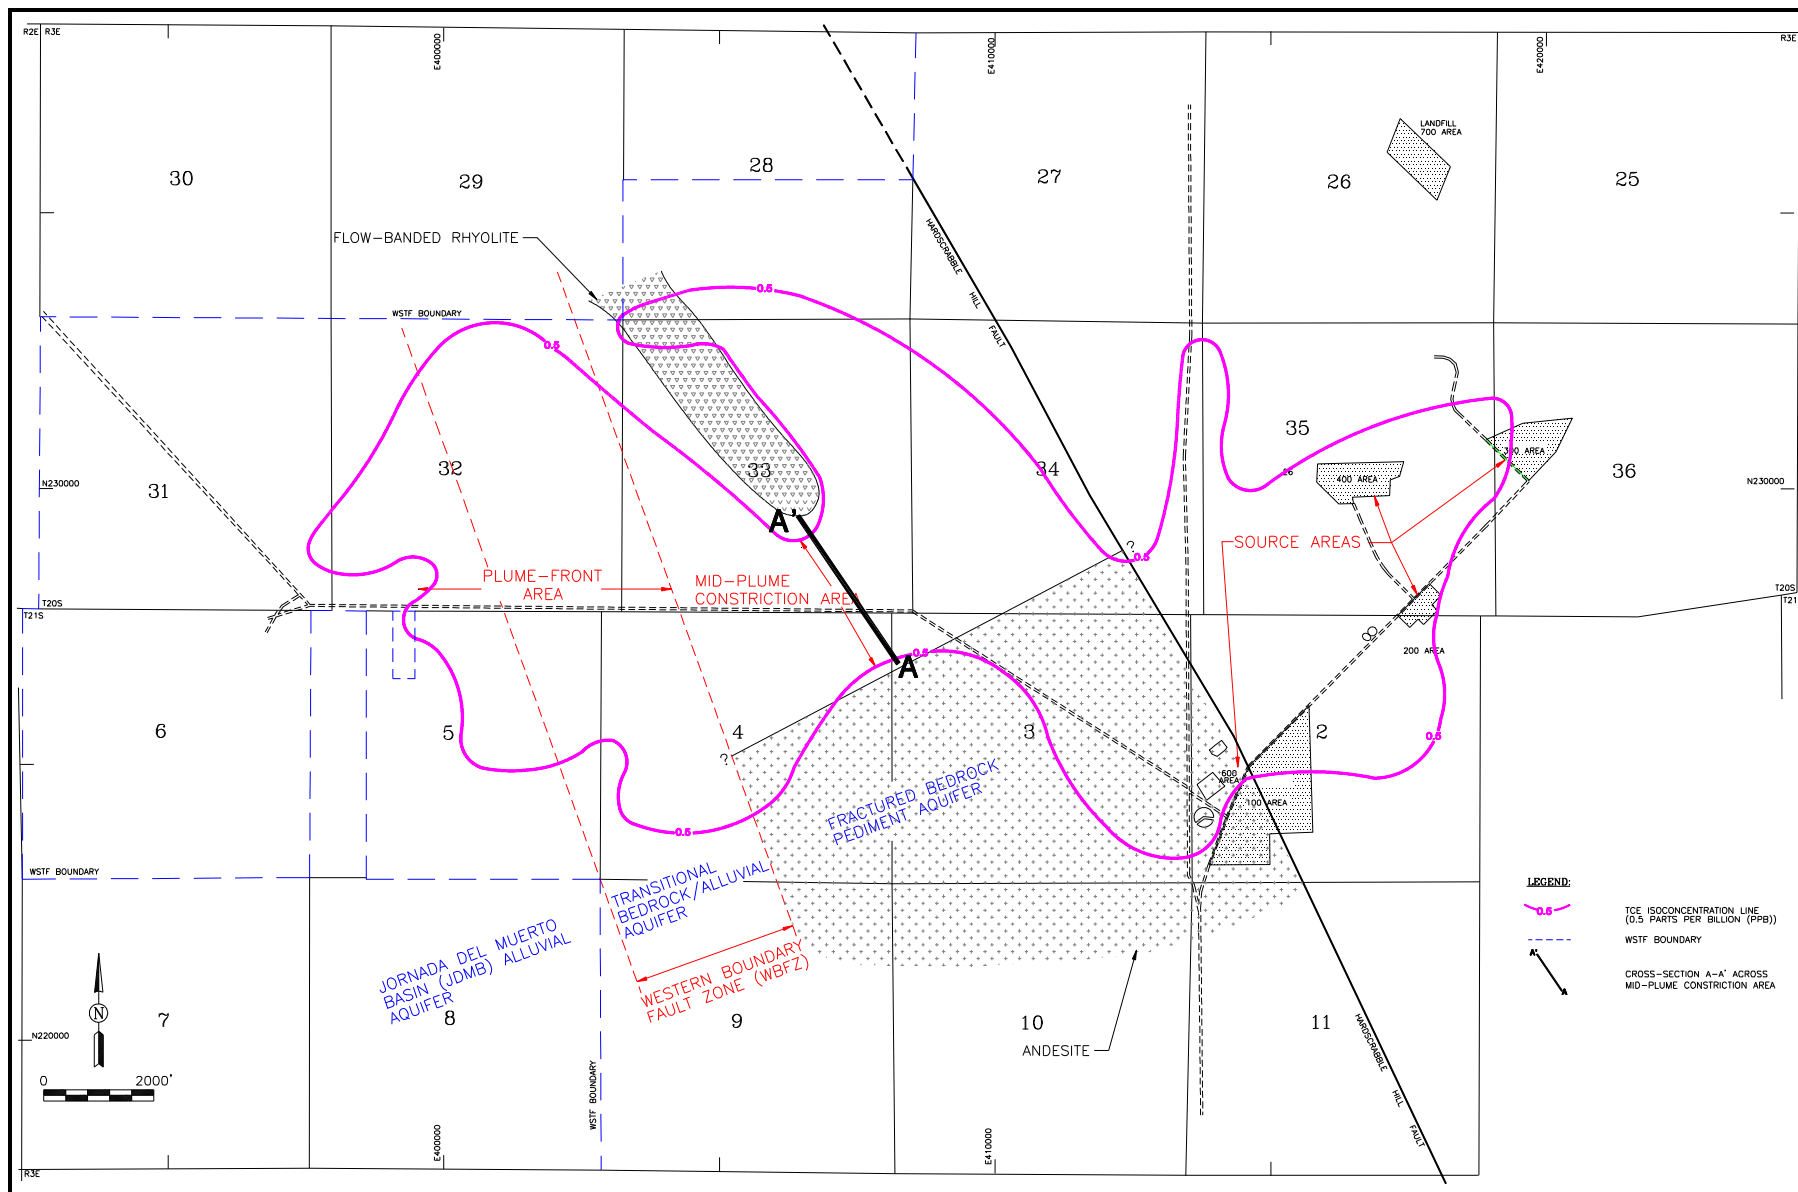
Figure 4- Groundwater Plume Hydrogeological Features

Two hydrogeologic groundwater flow barriers have been identified on the WSTF pediment slope within the mid-plume, semi-confined, fractured bedrock aquifer (Figure 4). Secondary porosity consisting of fractures with dips ranging from 45 to 65 degrees with minor separation predominates within the aquifer. These barriers combine to form the narrow MPCA. To the north, the northwest-southeast trending FBR unit with low permeability and transmissivity restricts groundwater flow. Groundwater sample analyses within the FBR indicate no detectable contaminant concentrations. To the south, a second flow barrier is created by andesite that has been altered to impermeable clay, promoting low hydraulic conductivities and no detectable contaminant concentrations. The barriers result in a natural confining area to contaminant flow both to the north and south. In the MPCA, groundwater occurs at a depth of 90 m (300 ft) bgs and is coincident with bedrock (Figure 5).

The FBR forms a distinct hydrostratigraphic unit that is fundamental in creating the MPCA. The depth of the aquifer in the MPCA is approximately coincident with fractured bedrock at 98-107 m (320-350 ft) below ground surface (bgs). A detailed cross-section of the MPCA is provided in Figure 5. The cross-section location is provided on Figures 4 and 9.

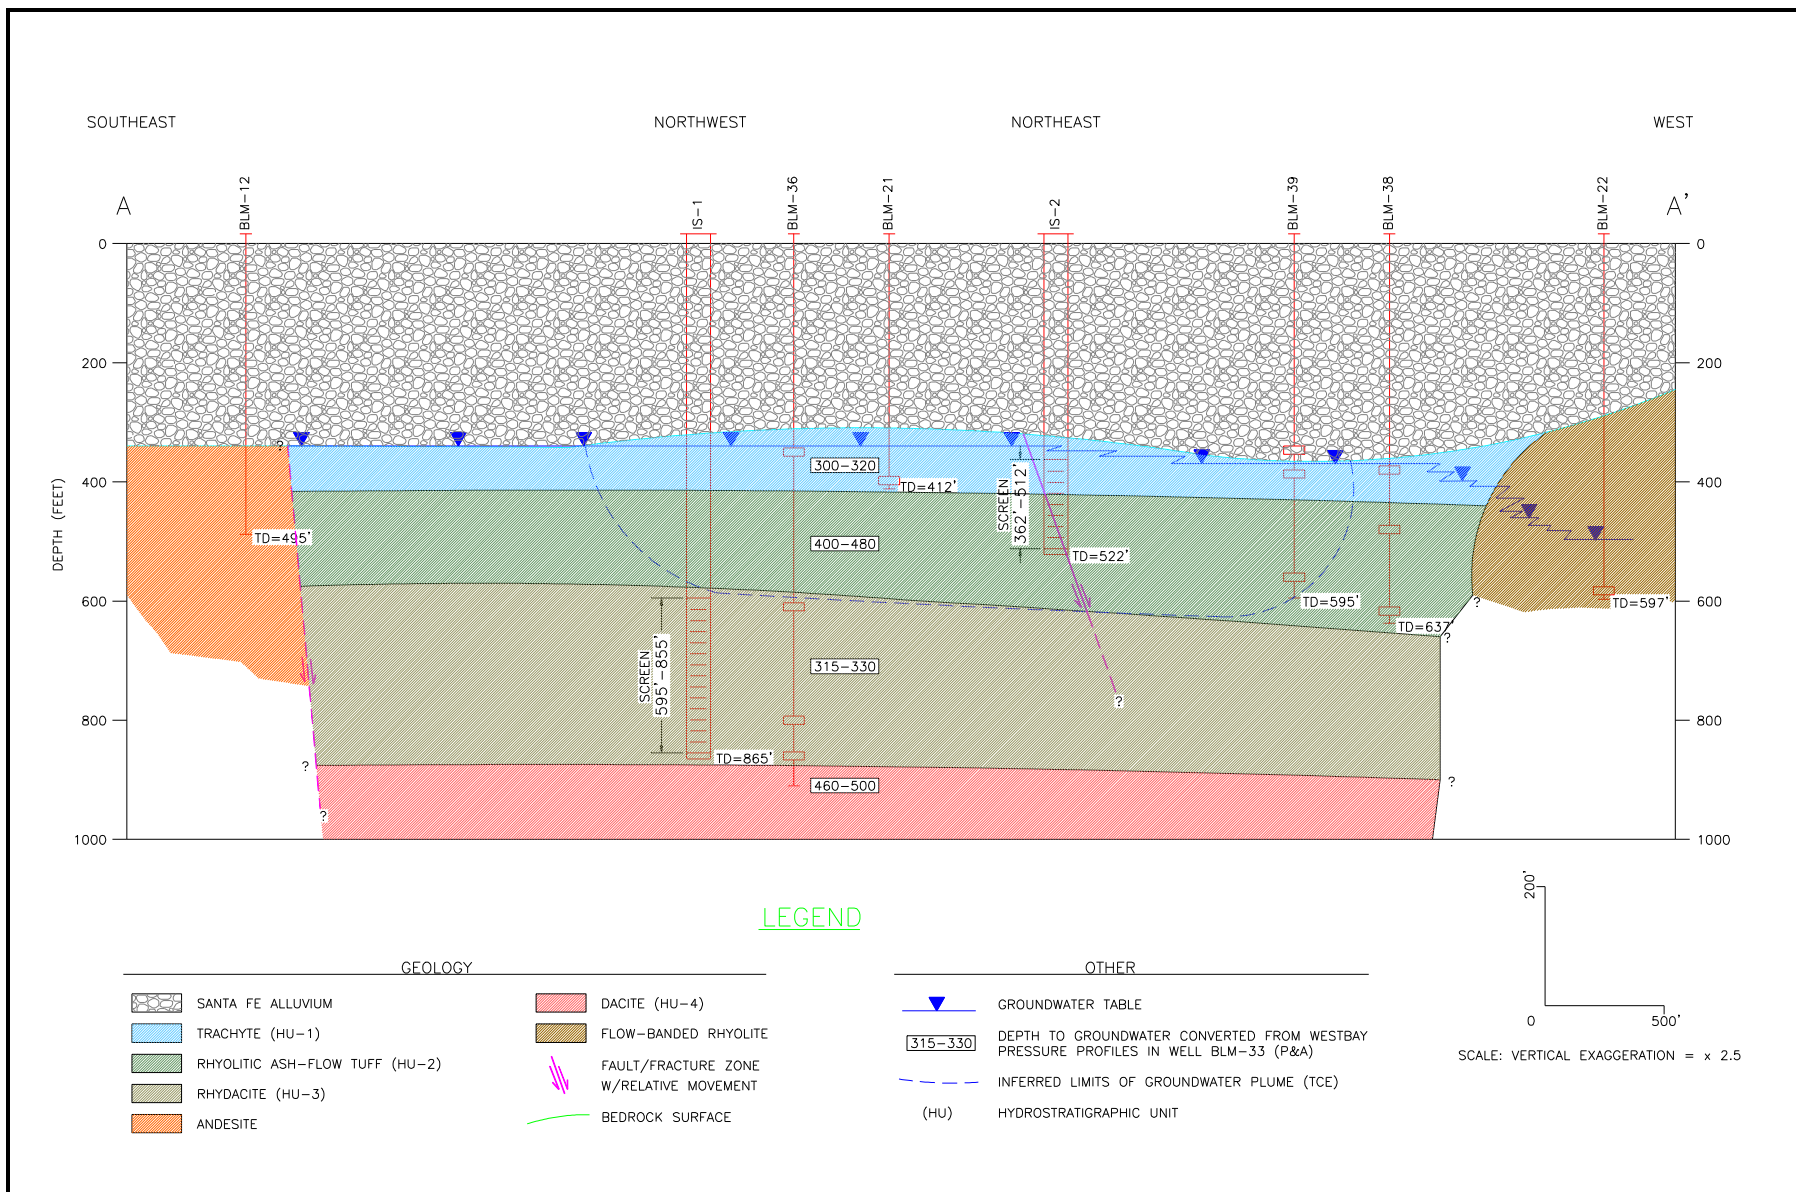
Figure 5 - MPCA Cross-Section

Groundwater flows from east to west through the MPCA with an average hydraulic gradient of 0.02 m/m (0.02 ft/ft). Four hydrostratigraphic units which dip gently to the west are identified in the volcanic bedrock (Figure 5). The uppermost two units (1 and 2) are a trachyte flow 15-18 m (50-60 ft) thick and a rhyolitic tuff 37-76 m (120-250 ft) thick which yield 3.8-19 lpm (1-5 gpm). The third unit is a series of interlayered rhyolite and rhyodacite flows 76-98 m (250-320 ft) thick with a 23-76 lpm (6-20 gpm) yield. At

the bottom of the section is a dacite of unknown thickness which yields <3.8 lpm (<1 gpm). The most productive hydrostratigraphic unit (3) is located at depths of 168 m (550 ft) to 259 m (850 ft) and was investigated as a potential target for MPCA interception by well IS-1 in September 1997.

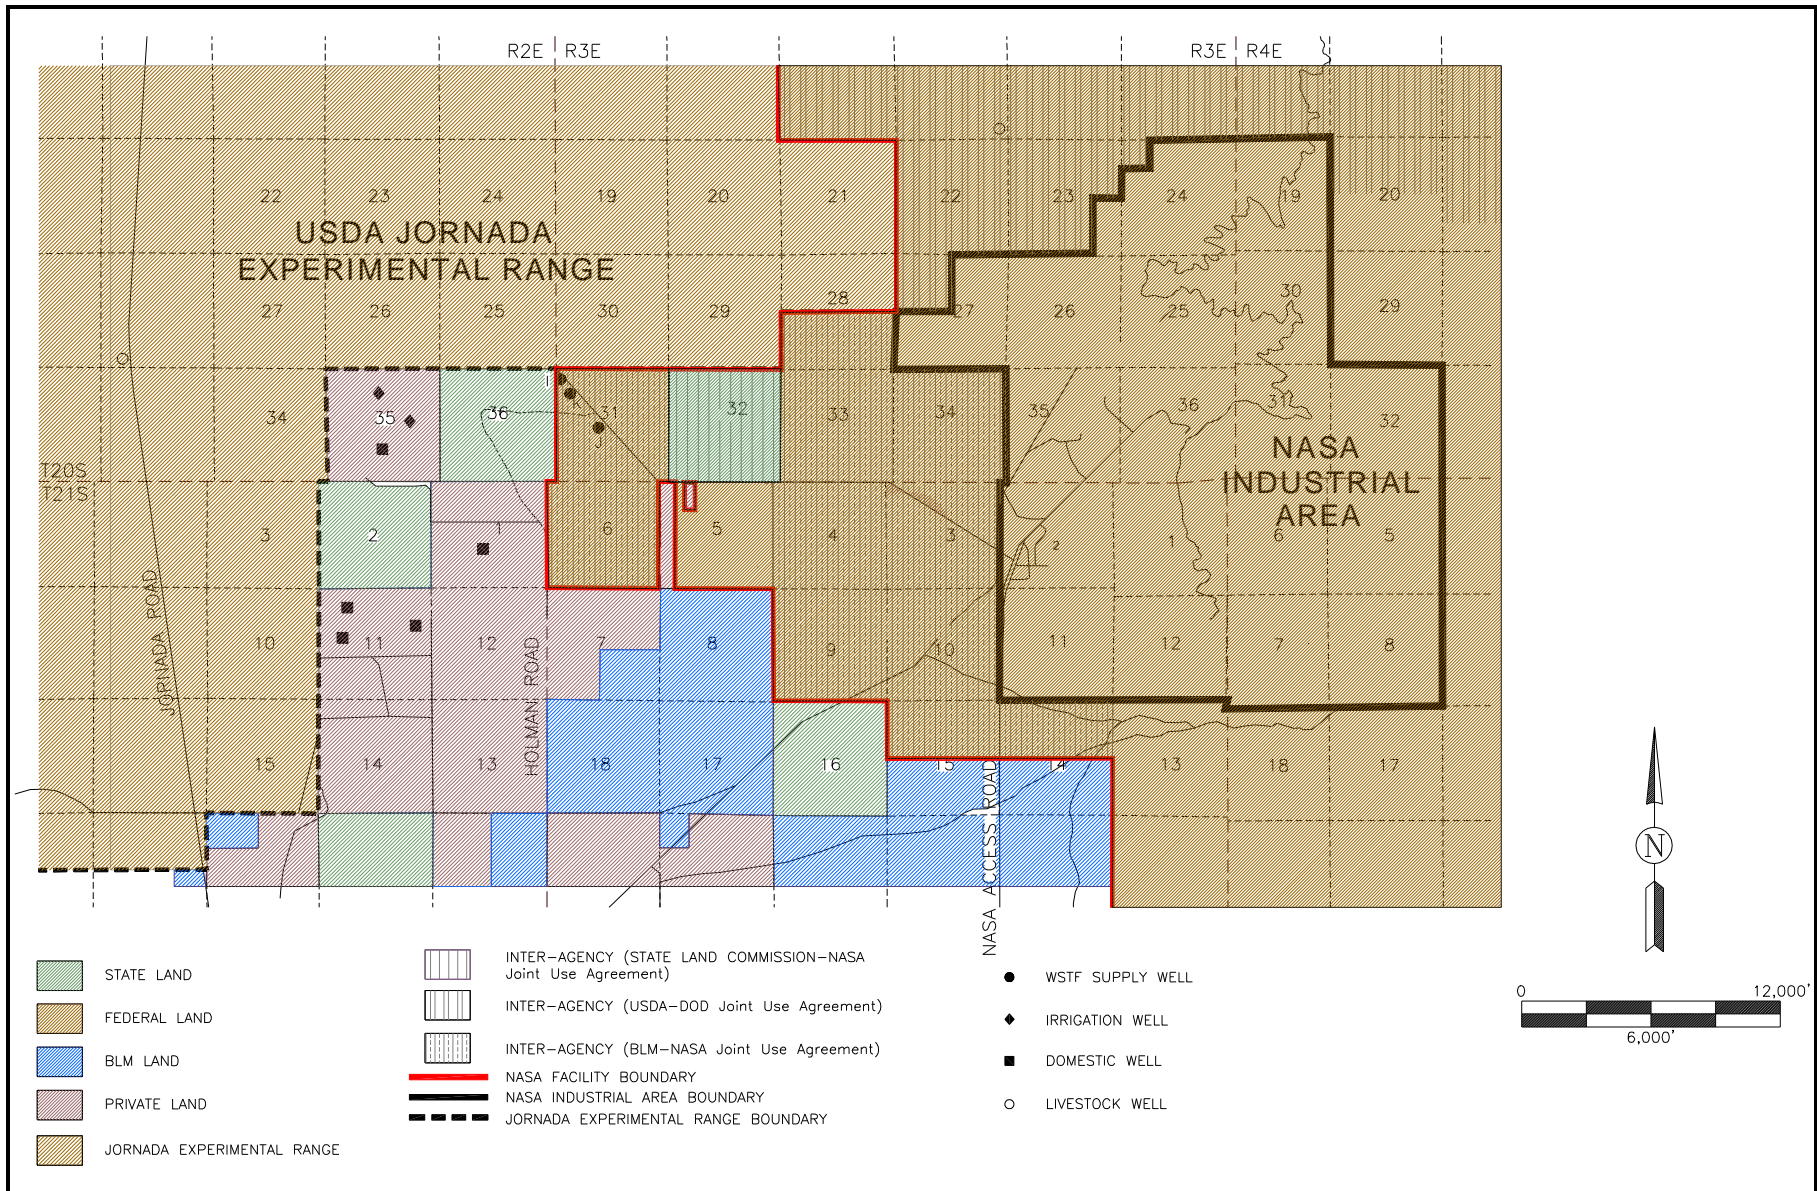
Figure 6 - Administrative Control

NASA maintains administrative control over land underlain by groundwater contamination (Figure 6). This land includes parcels owned by the U.S. Department of Defense, BLM, the State of New Mexico, and NASA. NASA's ownership or co-use control of this land precludes water extraction for the purpose of domestic or commercial use. The parcels of land proposed for the MPCA project include Sections 33 and 34 of T20S, R3E, and Sections 3, 4, and 5 of T21S, R3E. The WSTF buffer zone (approximately ten square miles west of the industrial facility) has isolated the facility from potential receptors of groundwater contamination. However, NASA instituted the plume-front containment project, with the proposed MPCA interception and remediation effort, to effectively mitigate plume migration, extract and treat contaminated water, and minimize risks to potential receptors and the environment.

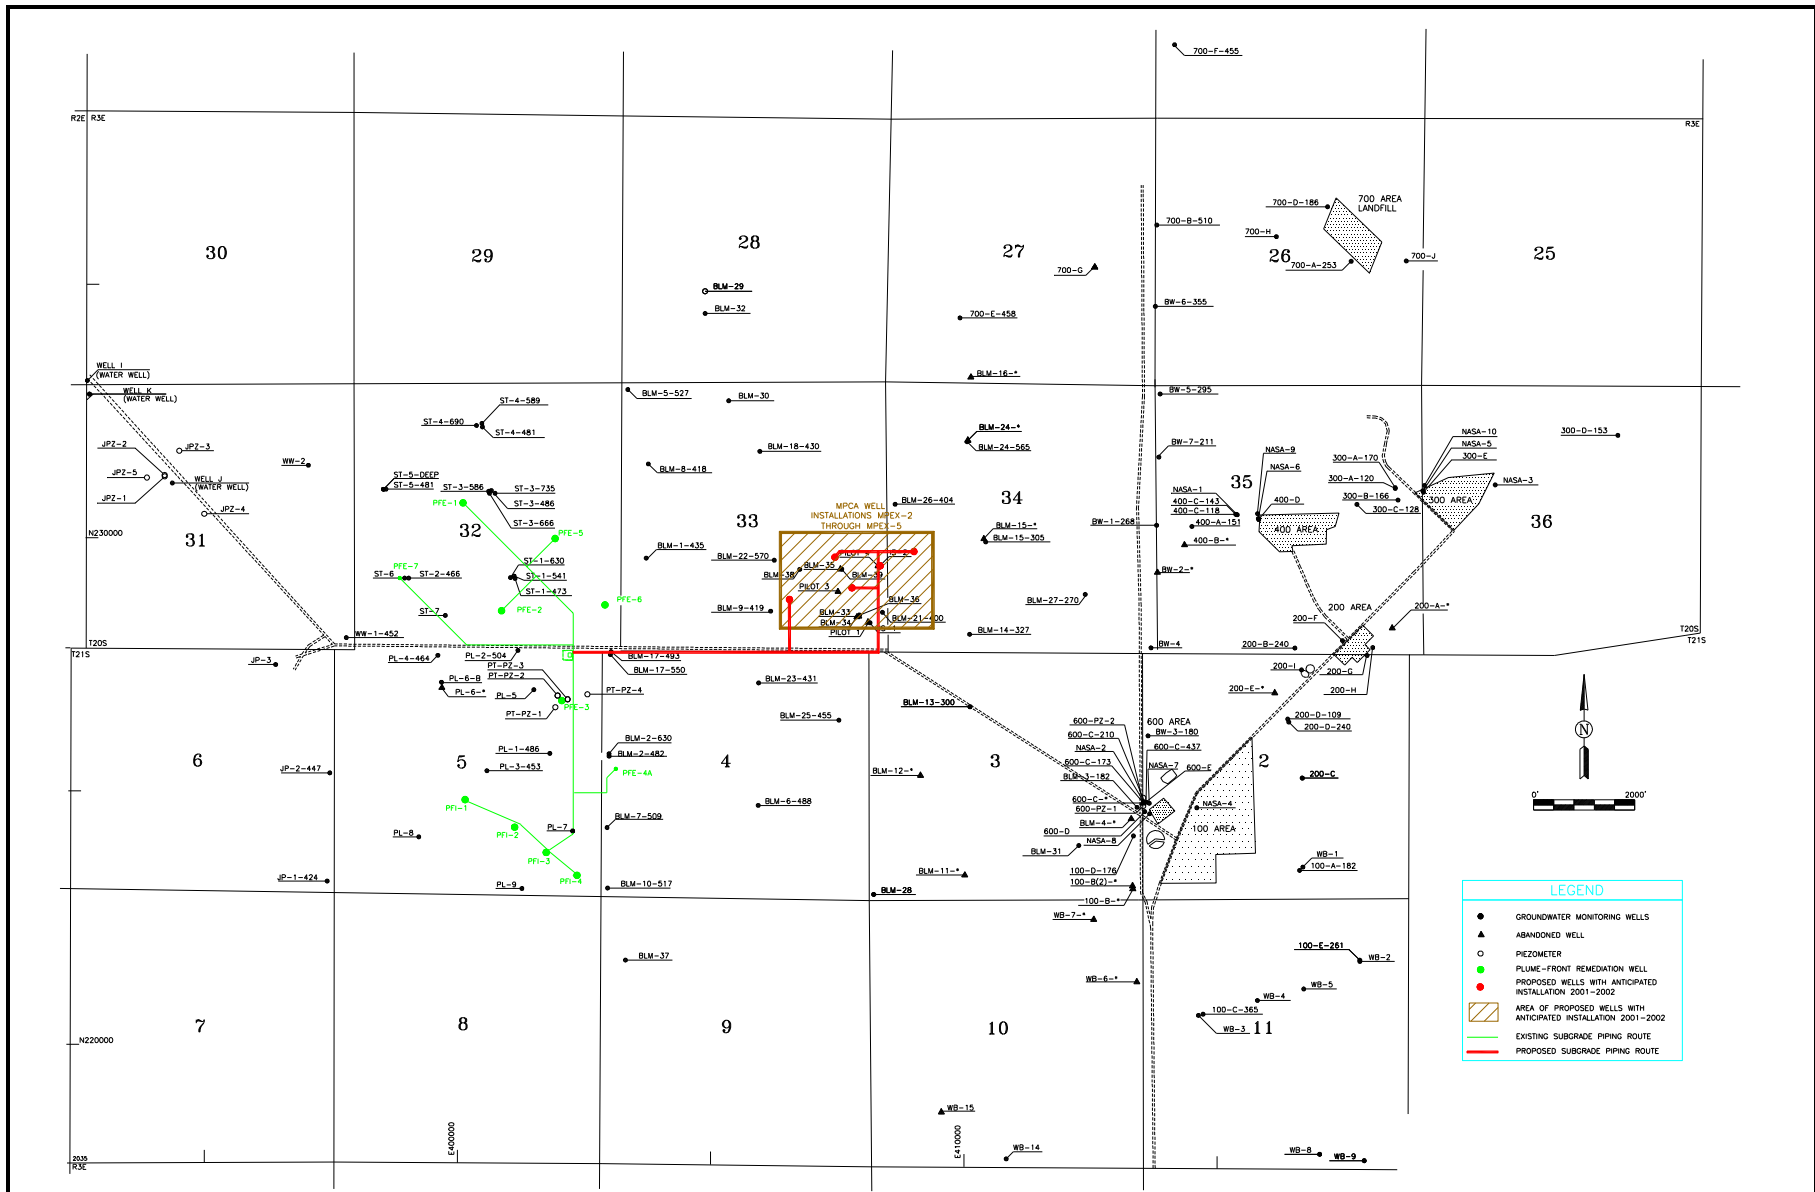
Figure 7 - MPCA Well Locations and Vicinity for Proposed Remediation Plan

The proposed MPCA action would contain contaminant mass flux to the western plume-front area by placing extraction wells at the narrow MPCA. This approach would form an effective barrier to contaminant transport. NASA proposes to install a series of five extraction wells and supporting above ground and sub-grade piping, electrical supply systems, access roads, and a possible pretreatment substation at the narrow MPCA to augment plume-front remediation efforts by eliminating westward contaminant mass flux. High contaminant concentrations and low groundwater volumes are particularly advantageous for remediation in the MPCA. Figure 7 provides the general area for the proposed locations of the extraction wells and piping. The proposed locations may be modified based on seismic analysis and discovery of a fracture system that would result in improved extraction. However, any new well locations would remain in the general MPCA area shown in Figure 7. A close-up drawing of the MPCA well locations, with proposed piping and electrical routes, is provided in Figure 8. An MPCA interim measure evaluation has been completed for this project. Using computer modeling, NASA has determined that mid-plume interception and treatment of the groundwater contamination is feasible. This information was not available at the time the final EA for the plume-front remediation plan was completed.

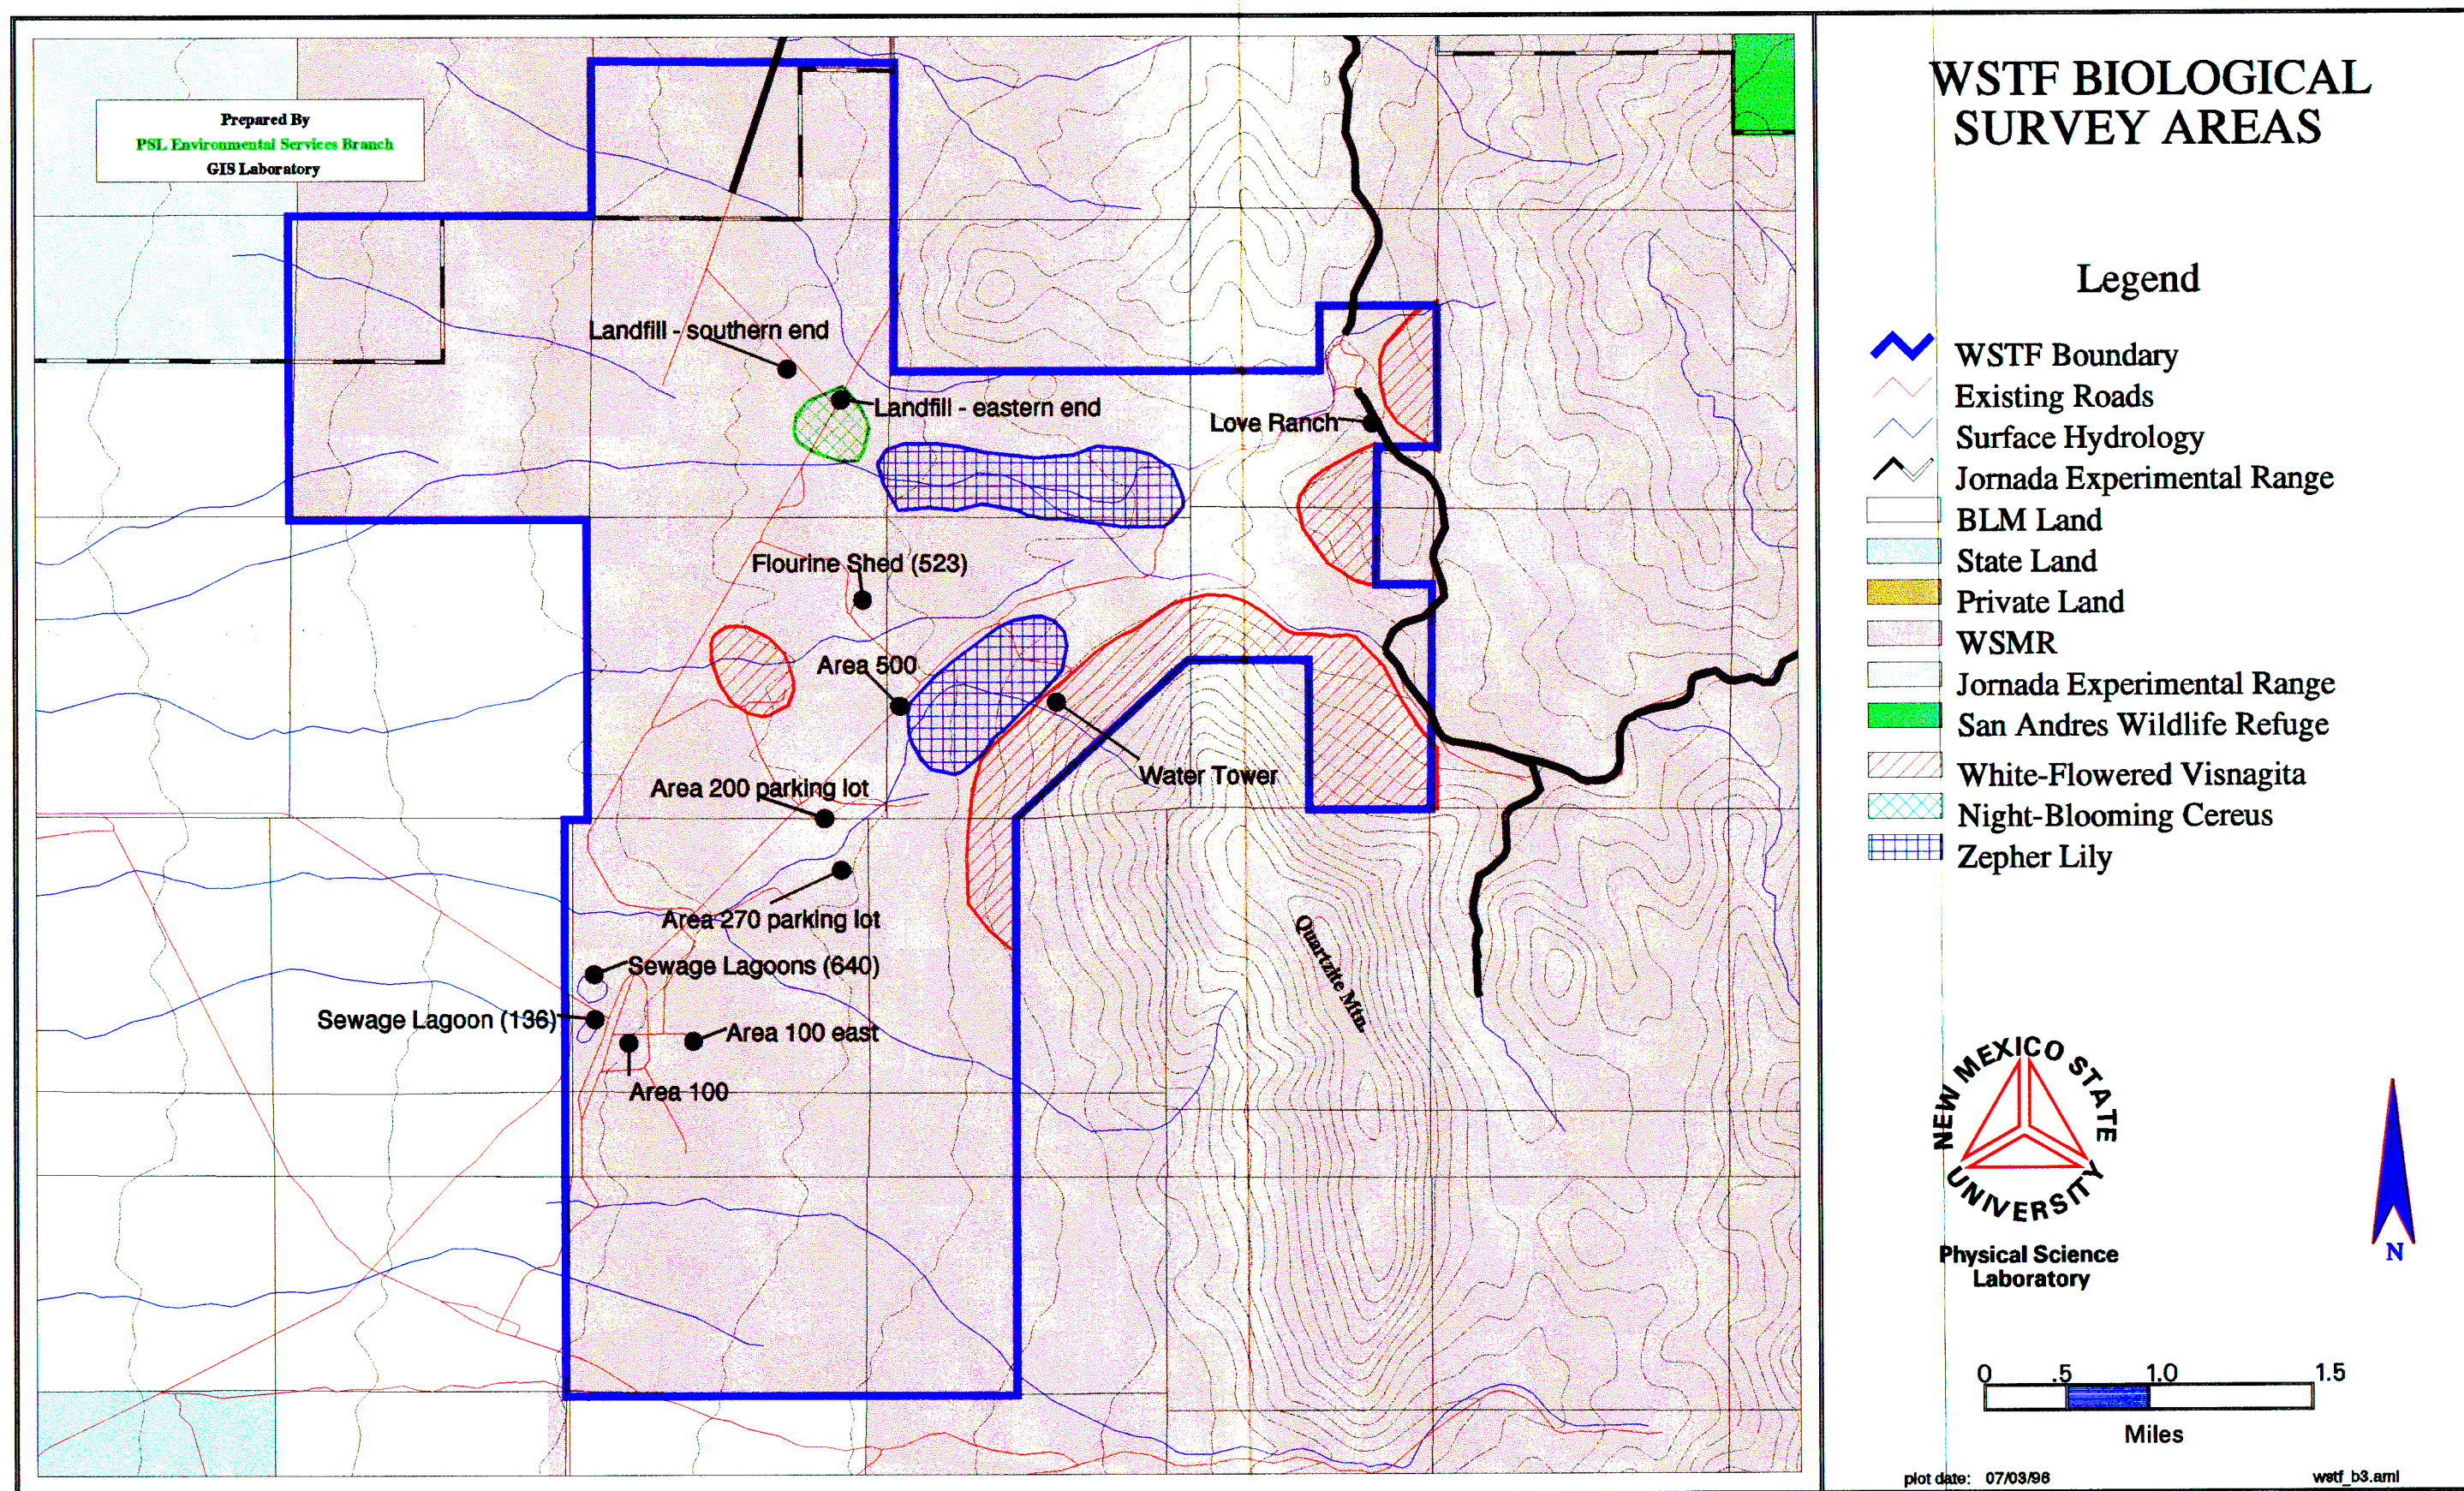
Figure 3. Distribution of Listed Species of Plants.

Two specimens of the Night-blooming Cereus (*Peniocereus greggii* var. *greggii*) were observed on the east side of the Landfill, approximately 1.3 km (2 mi) west of Bear Canyon (Figure 3) at an elevation of 1,600 m (5,250 ft). One specimen was located along a utility access road in the shade of a Creosotebush (*Larrea tridentata*), and within the alluvial fan of Bear Canyon. The

In addition, White-flowering Visnagita (*Neolloydia intertexta* var. *dasyacantha*), State of New Mexico "Plant Taxa Considered, But Not Included" (L4-1) was observed in this section (Figure 3). Most individual plants were observed on the lower northeast facing slope of Quartzite Mountain in limestone soil, associated with Alkali Sacaton (*Sporobolus airoides*).

Because of the lack of ponds, streams, and wetland habitat, the number of species of amphibians was low. Man-made watering areas associated with Section 25 and 26 (Water Tower and the 200 Area), and Section 2 (Sewage Lagoons [Nos. 640 and 136; Figure 3]) provide extremely

During the biological survey, 8 large stick nests were found within Sections 5, 6, 31W and 32W (Figure 3). All nests were in relatively good structural condition and were located in sandy clay swales and playas within Chihuahuan desertscrub vegetation. The primary nest-tree species were Honey Mesquite and Desert Sumac. Six nests contained young Chihuahuan Ravens (*Corvus cryptoleucus*), whereas two nests contained chicks of the Swainson's Hawk (*Buteo swainsoni*). A spring follow-up raptor survey should be conducted throughout all low lying habitat to determine the percent use and fledgling success rate of desert-scrub habitat by raptors on all low-lying WSTF property. In addition, every effort should be made to avoid impacting raptor nests or disturbing nesting and fledgling raptor chicks.

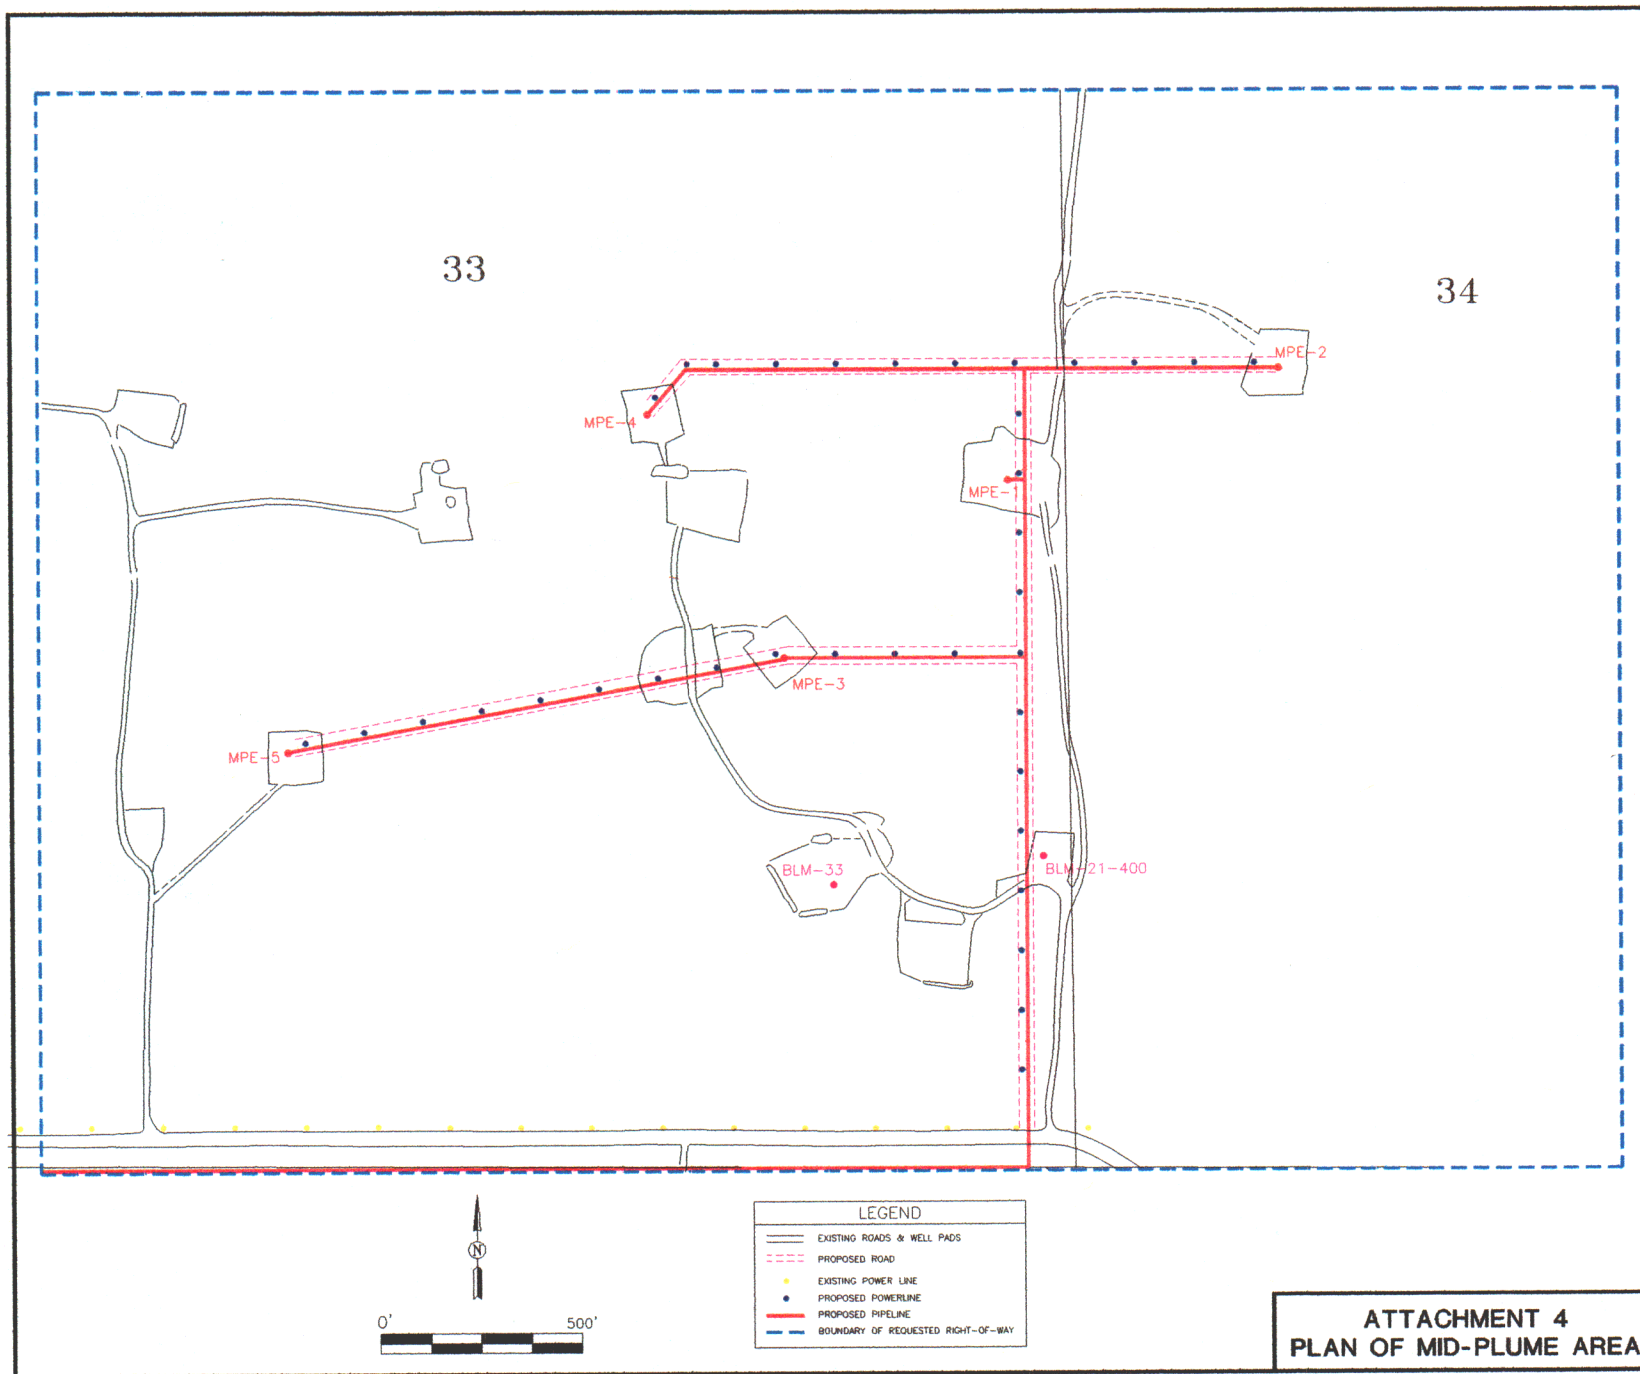
ATTACHMENT 4
PLAN OF MID-PLUME AREA

NDMA (ppt)	DMN (ppt)	TCE (ppb)	PCE (ppb)	Approx Flow (gpm)
MPE-1	5,300	1,566	78	2.6	16
MPE-2	ND	ND	ND	ND	5
MPE-3	8,630	3,210	98	3.8	4
MPE-4	3,600	2,030	46	1.8	4
MPE-5	3,170	1,120	130	3.8	2

Trench Length: ~ 6750 feet

Design Flow Rate: 80 gpm maximum
